TEST REPORT No: 9188-3. Page 1 of 3

«TRIFLEX» DOUBLE GLAZING WITH MATERIAL TESTED:

VENETIAN BLIND

PURPOSE OF THE REQUEST: **DETERMINING THE DURABILITY OF THE**

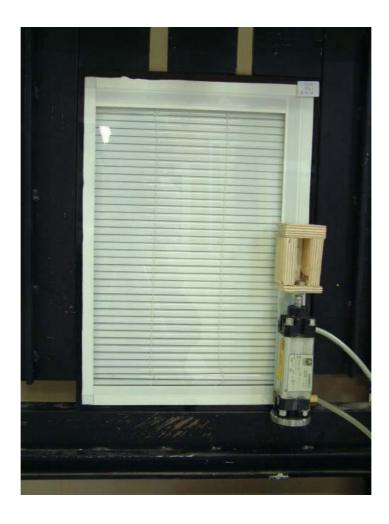
The sample was placed on a metal frame with a pneumatic system containing a cycle counter that drove the magnetic mechanism, as shown in the following photograph:

In this way, 100,000 opening and closing cycles were applied to the blind over its 80 mm run.

After 100,000 opening and closing cycles, no defects were noted in the operation of the Venetian blind.
